Pre-Demolition Asbestos and Hazardous
Materials Survey
of

10221 W Coldwater Road,
Flushing, MI 48433

TEC Project Number: 64823

March 17, 2025

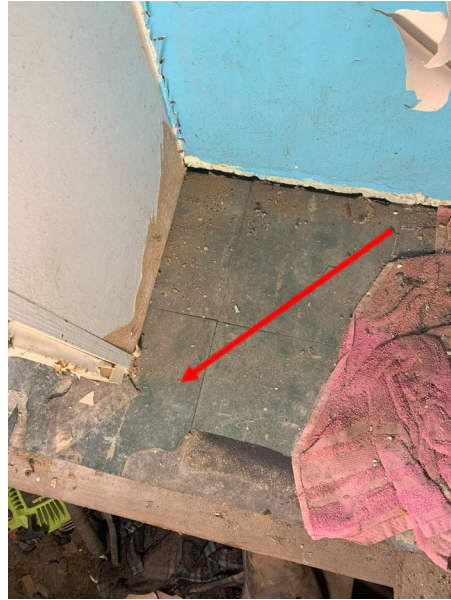
**Asbestos-Containing HM# 12 - Multilayer
Flooring (Top – White) w/ Tar Paper & Floor Tile
(Green) w/ Mastic**

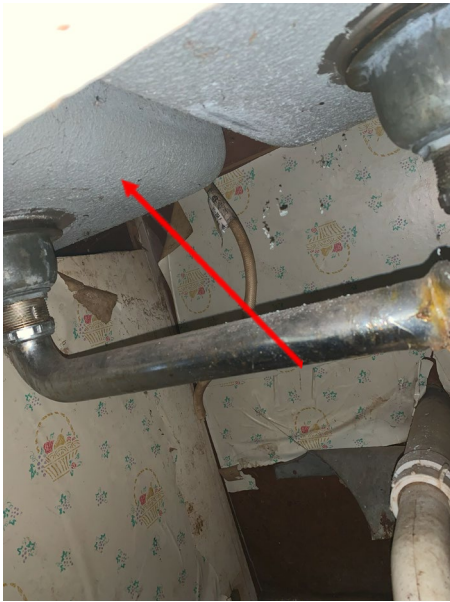
**Asbestos-Containing HM# 15 - Sink Undercoat
(Grey)**

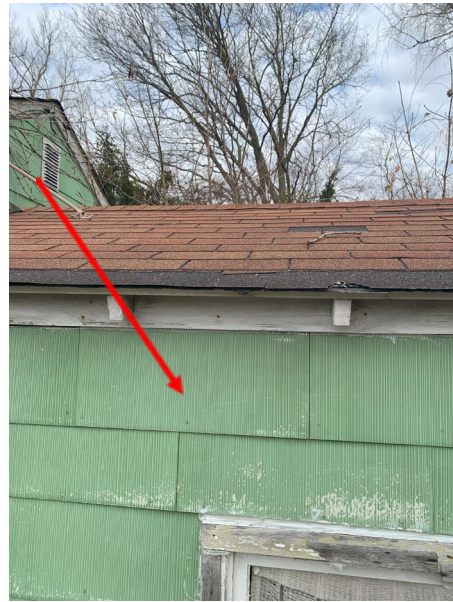
**Asbestos-Containing HM #22 - Cementitious
Siding (Painted – Green)**

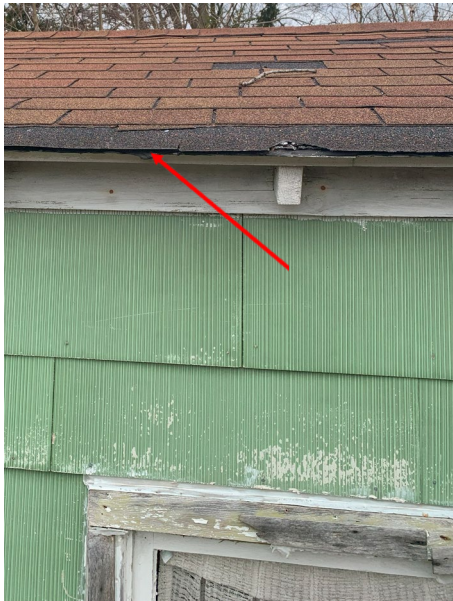
Asbestos-Containing HM #27 - Roof Tar (Black)

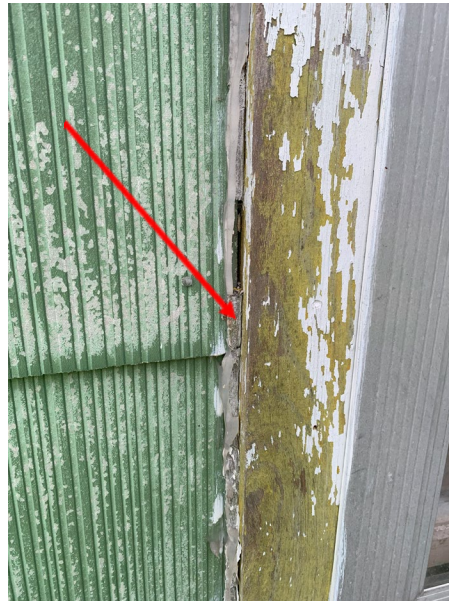
Asbestos-Containing HM #28 - Exterior Caulk (Grey)

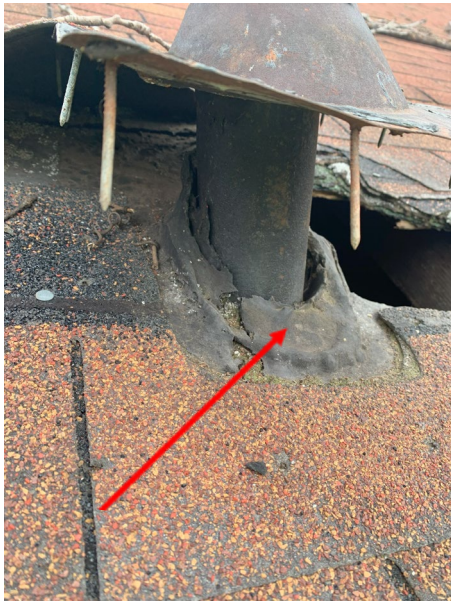
Asbestos-Containing HM #30 - Roof Flashing (Black)

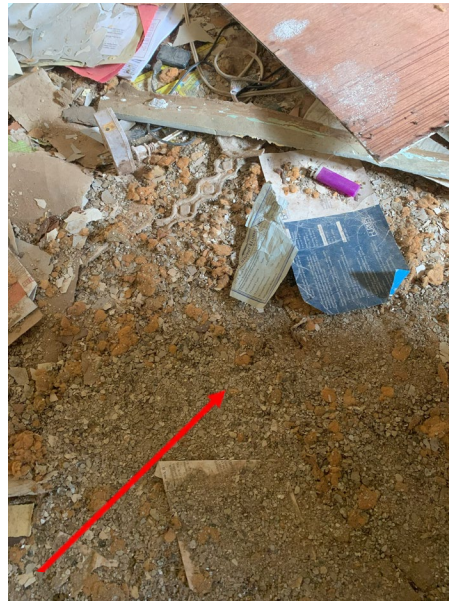
- Vermiculite – FS 10 (Attic) – 550 cubic feet
 - Due to Poor building conditions, vermiculite is throughout the structure (FS 2-9) and all debris is considered contaminated

Assumed Asbestos-Containing Vermiculite

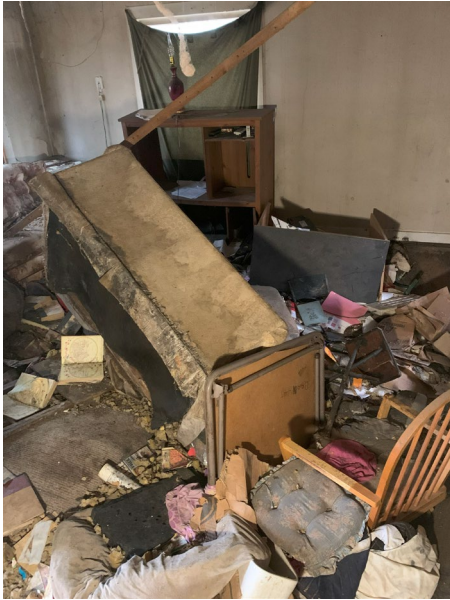
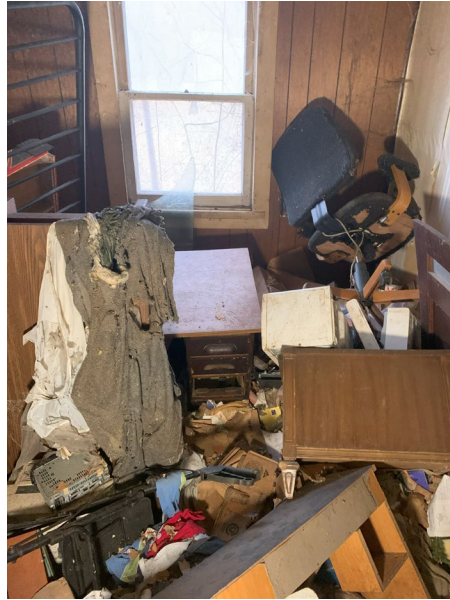
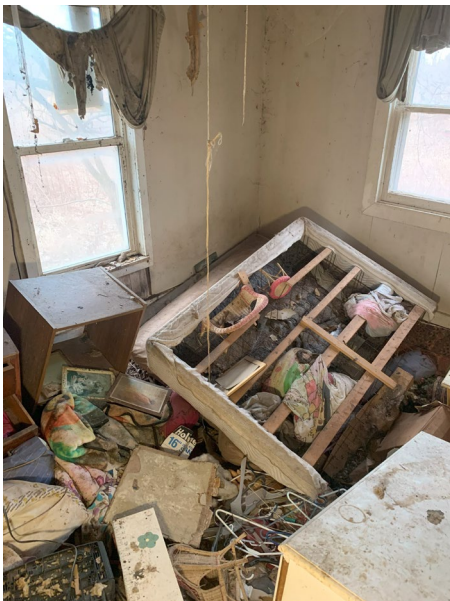
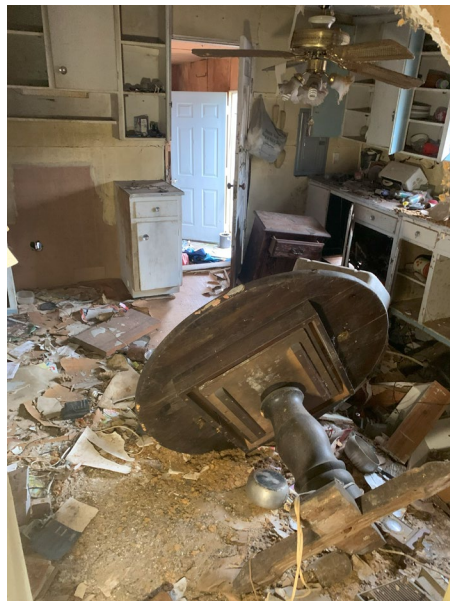
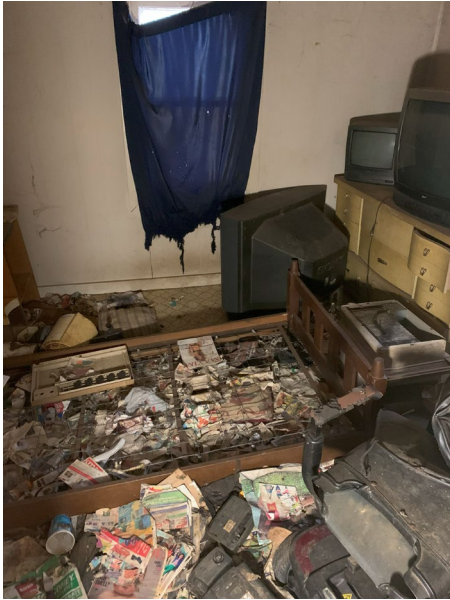
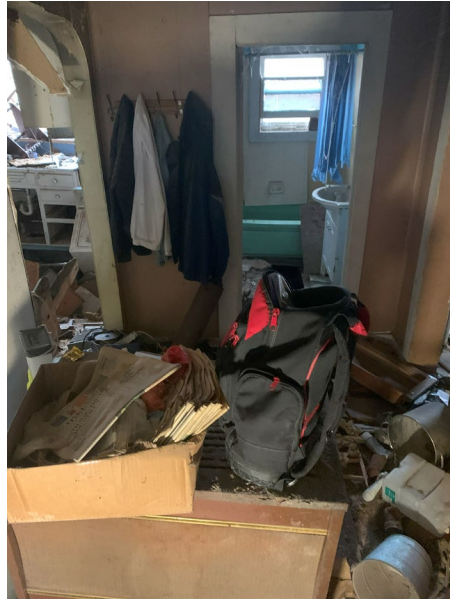
The ACMs identified in the subject building were generally found to be in poor condition.

General Photo of Building Conditions
